The ECU+ Fuel/Timing/Datalogging Piggyback Engine Computer

Version 2.15 Upgrade Guide

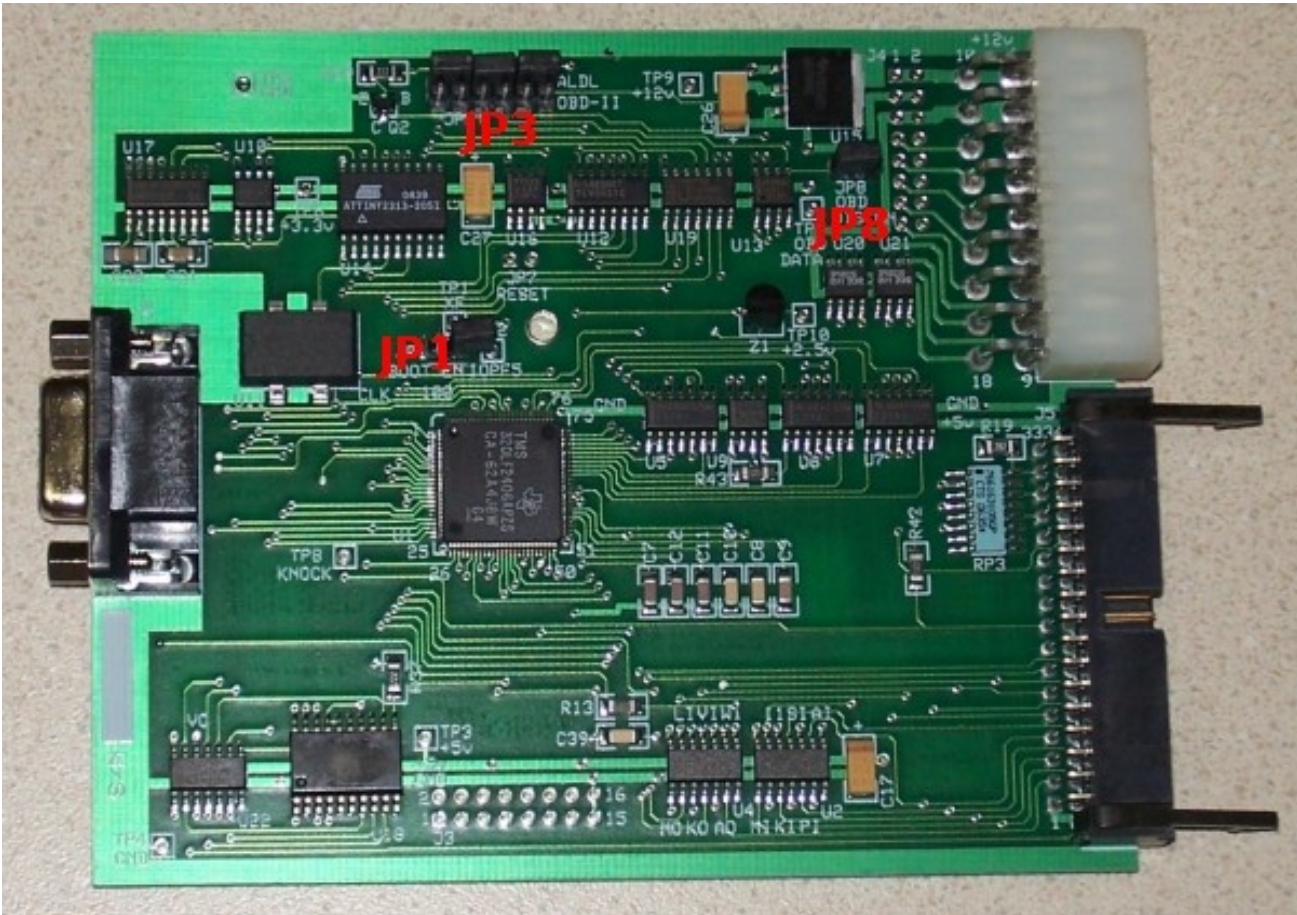
Illustration 1 - Jumper locations

Illustration 1 Shows an ECU+ circuit board, and the locations of JP3 and JP8. These are the two jumpers that may need to be modified.

Jumper JP8 (top right of the board) is the so-called *OBD-II Disconnect* jumper. On some of the ECU+ circuit boards with S/Ns of 2000-2099, this jumper is not shorted (connected) at the factory. To correct this, simply jumper the two pins of JP8 together with the jumper plug that's “hanging” off of one of the JP8 pins. A shorted JP8 is shown in Illustration 2 below.

Jumper JP3 (top center of the board) is the so-called OBD Mode jumper. This set of three jumpers swaps in the hardware necessary to allow the ECU+ 's OBD port to talk to your stock ECU for OBD-II screens and MUT-II datalogging. Two jumper configurations are supported:

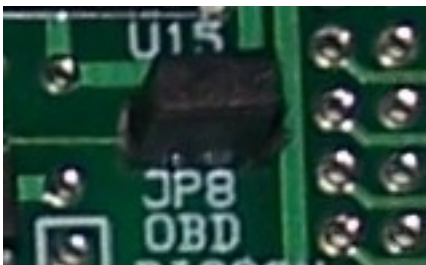
Illustration 2 - Connecting JP8

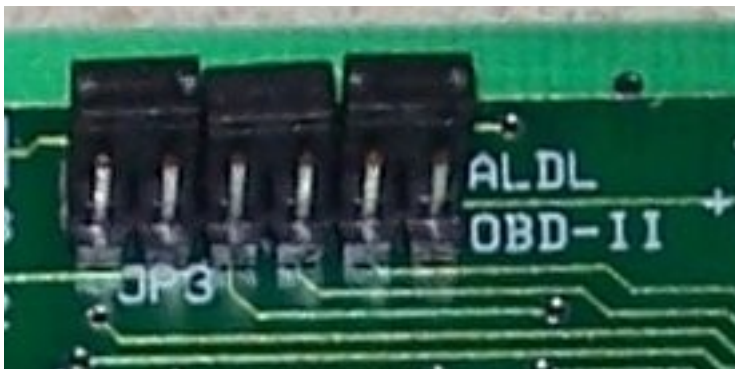
Illustration 3 - JP3 jumpers in ALDL mode (1G DSMs)

If you have a 2G DSM or EVO stock ECU, no changes to these jumpers need to be made. If your stock ECU is from a 1G DSM, you'll need to alter the JP3 jumper configuration to use *ALDL* mode. The figures below illustrate the jumper configuration for the two modes.

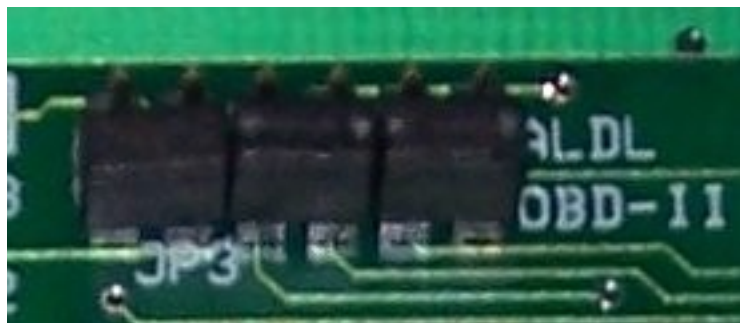
Illustration 4 - JP3 jumpers in OBD-II mode (2G DSMs and the EVOs)
